UNITED STATES ENVIRONMENTAL PROTECTION AGENCY
REGION III
1650 Arch Street
Philadelphia, Pennsylvania 19103-2029

The Environmental Protection Agency ("EPA") Region III along with the *appropriate State Agency*, will conduct a multi-media compliance inspection at **the US Postal Vehicle Maintenance Service beginning on Monday, November 24, 2003**. This letter will serve as EPA's official inspection notification. The inspection and this request for information are authorized under the provisions of the Clean Water Act ("CWA"), Section 308, 33 U.S.C § 1318; the Resource Conservation and Recovery Act ("RCRA"), Section 3007, 42 U.S.C. § 6927; the Toxic Substances Control Act ("TSCA"), 15 U.S.C § 2610; the Emergency Planning and Community Right to Know Act ("EPCRA"), Section 313, 42 U.S.C. § 11023; and the Clean Air Act.

Diagram #1

USPS VEHICLE

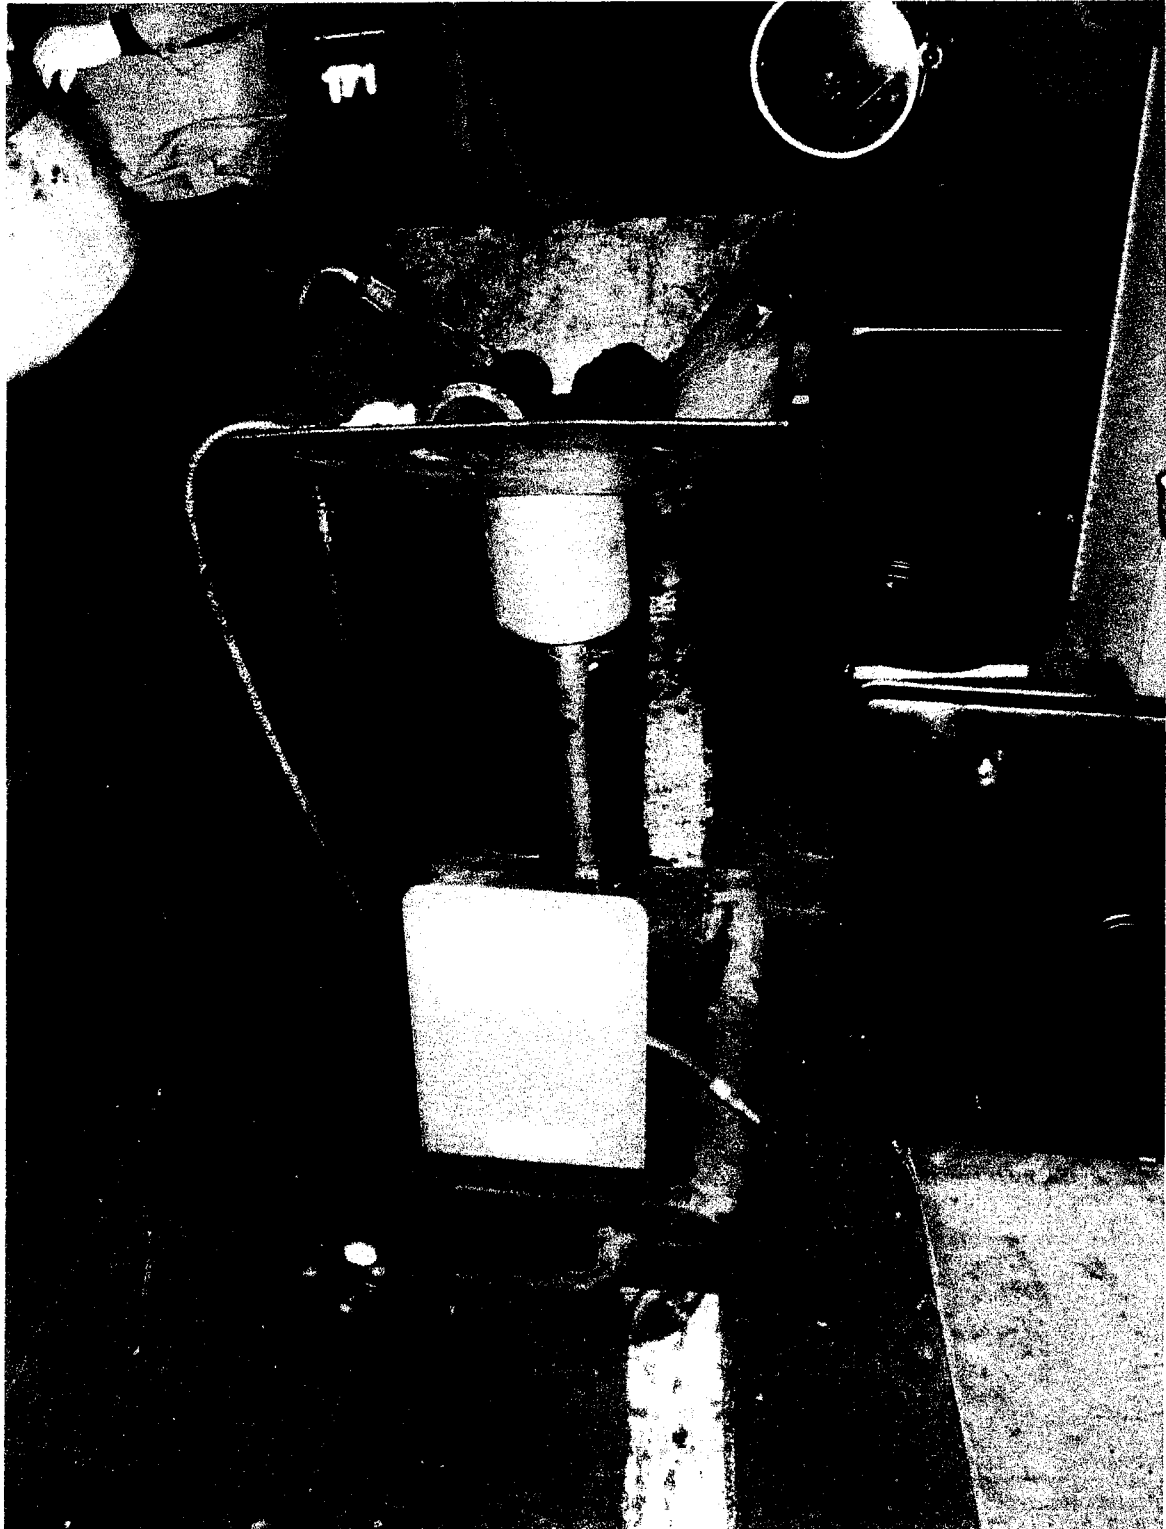
Brake Washer Residue Waste Stream

Waste Characterization Report

Sample ID: BVMF-WC03						
RCRA Characteristic	Date Sample Collected	Date Sample Analyzed	EPA ID Code	RCRA TCLP Limits	Result	Qualifier
% Solids	6/17/2003	6/23/2003	--	--	26.50%	
Ignitability (Flashpoint)		6/30/2003	D001	< 140	>200	
Corrosivity (pH Solid)		6/30/2003	D002	less than or equal to 2 or greater than or equal to 12.5	8.2	
Temperature at Analysis (°C)		6/30/2003	--	--	21.5

Brake Washer Residue is Non-hazardous.
